History and development of fishing boat construction In Central America.

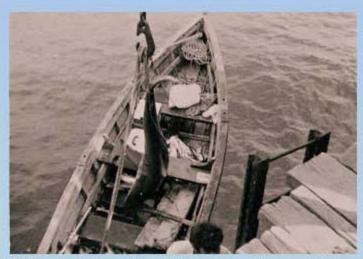
Lifting hoists work well from piers, thus providing Improved, but limited ACCESS TO THE SEA

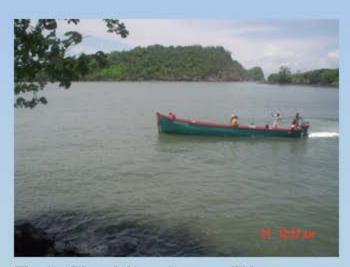
The traditional dugout canoe still has widespread acceptance.

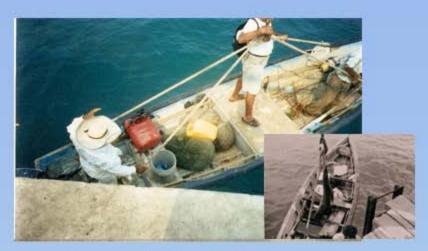
Fiberglass boats developed for the same use as their wooden predecessors.

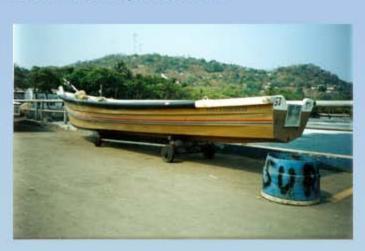
Clearly a design for larger outboard engines. Sails ? Oars ?

Typical design for a 21' fiberglass fishing boat, with installed icebox and other appliances.

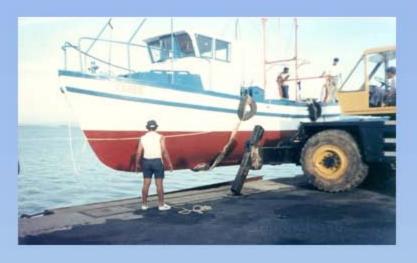
Deck, cabin, hydraulic winches, iced fish hold. Safety, range and autonomy.
